**Flood Control Project Maintenance
Levee Inspections**

Fall 2019 Levee Maintenance Deficiency Summary Report

Sacramento River Basin

Reclamation District No. 0070 Meridian

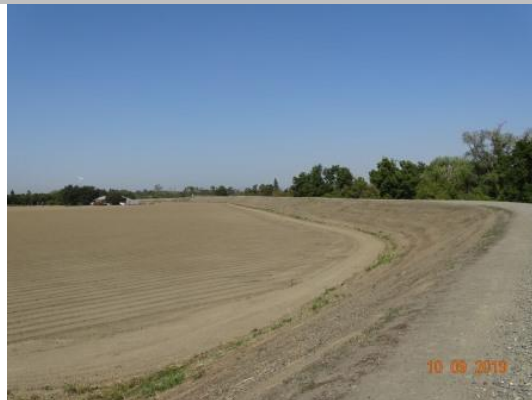
Photo 1 of 1 : FA_2019_RD0070_29_25_20191011_00071.jpg

LM Start	0.16	Rating **	A	Issue No.	25
LM End	0.16	Issue Type +	Ma	Location *	LS
Category	Earthen Levee			GPS Latitude/Longitude	
				Start	End
Item	Vegetation			39.138687°	39.138687°
				-121.836578°	-121.836578°
DWR ID	DWR_RD0070_01_f_2019_25				
Comment Code					
V1 : Control annual grass and weeds on the levee slopes and easements.					
Inspector Comment					
Good vegetation control is implemented on the landside and waterside slopes.

View of good vegetation control on the landside slope. Fall 2019.

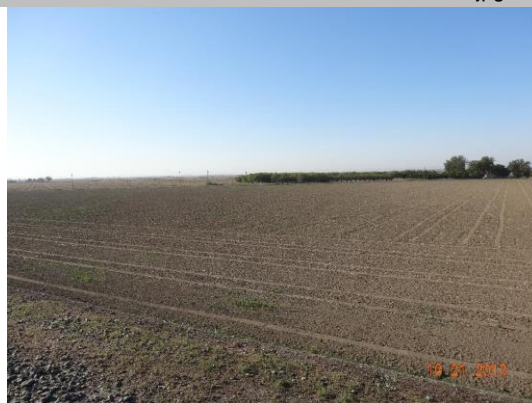
Photo 2 of 3 : UCIP_FA_2019_23463_40621.jpg

Comment Code					
Inspector Comment					
DS_ID:21347 FS_ID:23463 EP_NO: 3804 Repair Type: Non-Urgent Crossing Status: Indicator Found UCIP Comments: Unable to confirm if the indicators that were found in the field correspond to this crossing. Will need to contact PG&E to confirm location of crossing. Photos will need to be updated if the photos attach do not correspond to this crossing. This crossing is referenced in the USACE Periodic Inspection as item USACE_CESPK_MRD1_2012_p_0304 for 12 inch gas pipe. Coordinates between DWR UCIP and USACE PI are approximately 630 feet apart. FIELD_STRUCT_DESC: 12-inch coated steel natural gas pipeline through the levee, 3.6 feet below the crown. Concrete cutoff wall around the pipe at the center of the levee. Marker sign on the waterside (WS) shoulder. Rock revetment on the WS slope. (Plans for installation of a 12-inch gas collecting line through the levee authorized under Permit No. 3804, 1961 - Pacific Gas and Electric Company [PG&E]). [Additional Reference(s): DWR Levee Log, 2007]. FS Date: 10/21/2013

View of landward side where gas line markers are visible approximately 900 feet from levee.

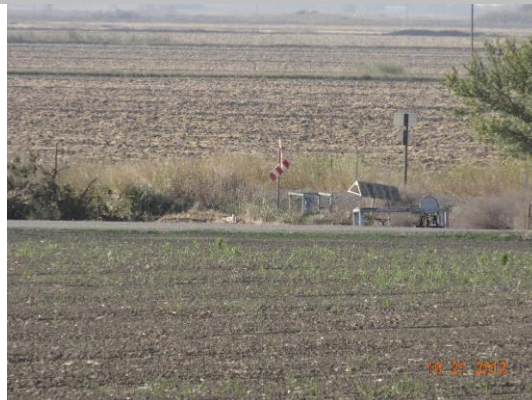
Photo 3 of 3 : UCIP_FA_2019_23463_40620.jpg

View of gas line markers approximately 900 feet away.

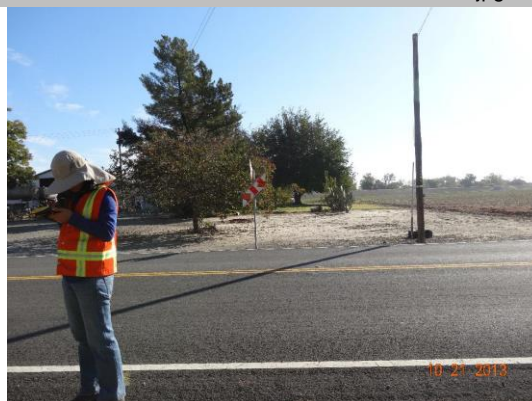
Photo 1 of 3 : UCIP_FA_2019_23384_40249.jpg

Comment Code						
Inspector Comment						
DS_ID:21415 FS_ID:23384 EP_NO: 15936 Repair Type: Non-Urgent Crossing Status: Indicator Found UCIP Comments: No markers visible on levee slope or levee toe to indicate line crosses levee. Need to contact PG&E to confirm location through levee. Also need to confirm the emergency contact person for this crossing. FIELD_STRUCT_DESC: 8-inch steel natural gas pipeline through the levee, 2.5 feet below the crown. Gas line markers on the landside (LS). (Plans to remove an existing 16-inch pipe and install an 8-inch natural gas pipe to existing pipe within the 10-foot LS limits of the levee authorized under Permit No. 15936, 1992 - Pacific Gas and Electric Company [PG&E]). FS Date: 10/21/2013

View of markers on the east side of S. Tarke Road.

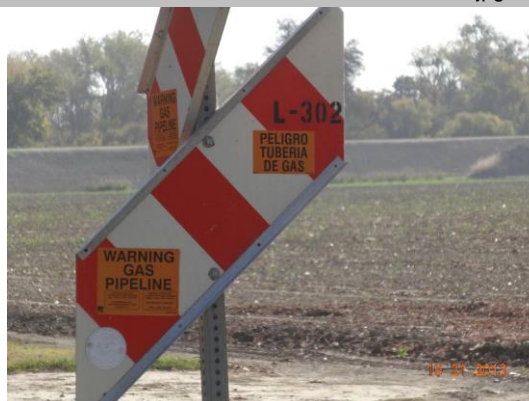
Photo 3 of 3 : UCIP_FA_2019_23384_40248.jpg

Comment Code						
Inspector Comment						
DS_ID:21415 FS_ID:23384 EP_NO: 15936 Repair Type: Non-Urgent Crossing Status: Indicator Found UCIP Comments: No markers visible on levee slope or levee toe to indicate line crosses levee. Need to contact PG&E to confirm location through levee. Also need to confirm the emergency contact person for this crossing. FIELD_STRUCT_DESC: 8-inch steel natural gas pipeline through the levee, 2.5 feet below the crown. Gas line markers on the landside (LS). (Plans to remove an existing 16-inch pipe and install an 8-inch natural gas pipe to existing pipe within the 10-foot LS limits of the levee authorized under Permit No. 15936, 1992 - Pacific Gas and Electric Company [PG&E]). FS Date: 10/21/2013

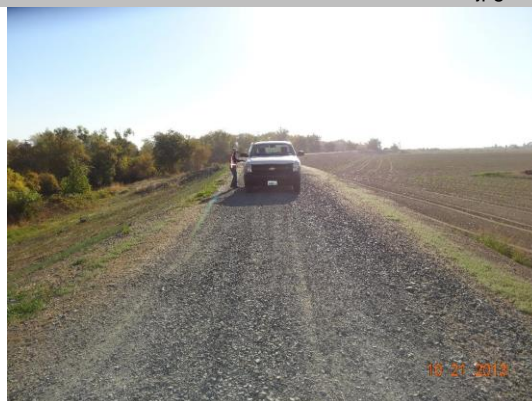
Photo 1 of 3 : UCIP_FA_2019_23503_40784.jpg

UCIP Comments: Dense vegetation limits the inspector's visibility to identify signs of pipe failure (leaks) along the waterward slope. Recommend removing vegetation along pipe alignment to conduct proper inspection of structure and appurtenances. Unable to find the gate valve on landward side. Walkway on waterward side in bad shape. This crossing is referenced in the USACE Periodic Inspection as item USACE_CESPK_MRD1_2012_p_0300 for 18 inch pipe. Pipe on LS is 10 inch not 18 inch. SEE UCIP DS_ID 21350 for details pertaining to 18 inch pipe.

FIELD_STRUCT_DESC: 10-inch irrigation discharge pipe of an unknown material through the levee, 14.8 feet below the crown. Electrical conduit through the levee, 1 foot below the crown. Pump on a pile structure in the stream. Service pole with meter and control panel at the landside (LS) toe. Slide gate with walkway on the waterside (WS) end. Gate valve on the LS end, not found during 10/21/2013 pipe inventory. Rock revetment on the WS slope. (Plans for removal of a pump on the LS and installation of a pump and two concrete piers on the WS authorized under Permit No. 3686, 1961 - Gerald A. Frye). [Additional Reference(s): DWR Levee Log, 2007]. FS Date: 10/21/2013

View of levee crown looking upstream from crossing.

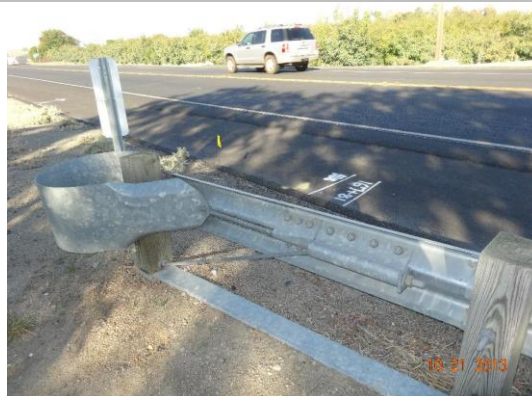
Photo 1 of 3 : UCIP_FA_2019_23467_40643.jpg

DS_ID:21354
FS_ID:23467
EP_NO: 14802
Repair Type: Non-Urgent
Crossing Status: Indicator Found
UCIP Comments: Need to contact owner to determine status of crossing. Need date of last inspection and confirmation that crossing is still in operable condition. Markers found about 159 feet upstream of coordinates at the crossing of the ramp and S. Tarke Road (39.142684, -121.842685).
FIELD_STRUCT_DESC: 4-inch steel natural gas pipeline through the levee, 2.5 feet below the crown. Aluminum pipe marker on the landside (LS) slope. Emergency contact information for Pacific Gas and Electric Company (PG&E): (800) 344-4749? or 4742? or (916) 742-3251. (Plans to replace an existing 3-inch natural gas main through the levee with a new 4-inch steel pipe authorized under Permit No. 14802, 1987 - PG&E). [Additional Reference(s): DWR Levee Log, 2007].
FS Date: 10/21/2013

Underground Service Alert (USA) flag located at the end of Hwy 20 confirming gas line goes through.

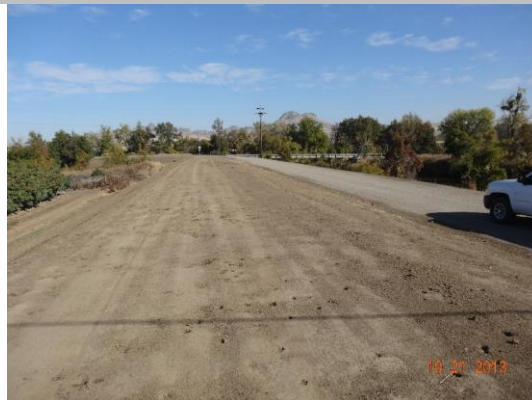
Photo 1 of 3 : UCIP_FA_2019_23526_40942.jpg

Comment Code						
Inspector Comment						
DS_ID:21355 FS_ID:23526 EP_NO: 9961 Repair Type: Non-Urgent Crossing Status: Found UCIP Comments: Dense burrow activity present on both waterward side and landward side. Recommend addressing burrow activity at this location. Also recommend having owner clear vegetation blocking access along walkway. This crossing is referenced in the USACE Periodic Inspection as item USACE_CESPK_MRD1_2012_p_290. FIELD_STRUCT_DESC: 10-inch (not 12-inch as referenced in the permit) steel irrigation discharge pipe through the levee, 5.4 feet below the crown. Siphon breaker in a corrugated metal pipe (CMP) riser on the landside (LS) slope. 24-inch concrete standpipe at the LS toe. Walkway to the pump on a pile structure in the stream. (Retention of a 12-inch steel irrigation pipe through the levee, 5.4 feet below the crown, a walkway to the pump on a pile structure in the stream, and a siphon breaker in a CMP riser on the landward slope authorized under Automatic Board Order (ABO) issued as Permit No. 9961, 1974 - Louis Tarke, Trustee). [Additional Reference(s): DWR Levee Log, 2007]. FS Date: 10/21/2013

View of levee crown and waterward berm looking downstream from crossing.

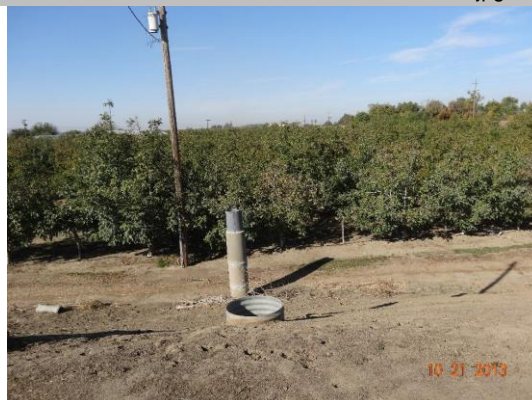
Photo 2 of 3 : UCIP_FA_2019_23526_40941.jpg

View of standpipe and CMP riser located on landward side.

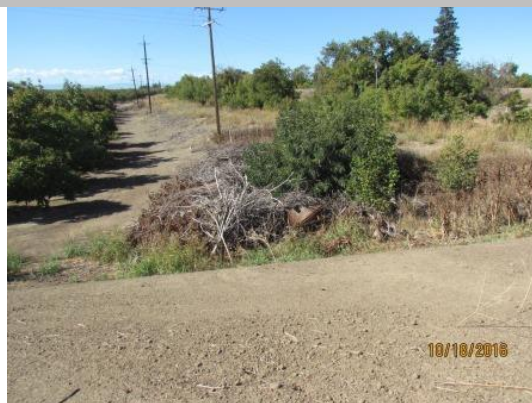
Photo 1 of 1 : FA_2019_RD0070_29_33_20190822_00007.jpg

LM Start	0.75	Rating **	M	Issue No.	33
LM End	0.75	Issue Type +	En	Location *	LS
Category	Earthen Levee			GPS Latitude/Longitude	
				Start	End
Item	Encroachments			39.145095 °	39.145095 °
				-121.842865 °	-121.842865 °
DWR ID	DWR_RD0070_01_f_2016_33				
Comment Code					
PR : Prunings					
Inspector Comment					
Prunings should be removed from the landside toe.

View of the prunings along the landside toe.

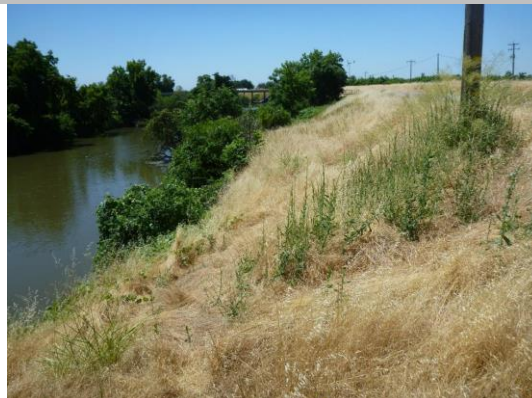
Photo 1 of 3 : LEVAL_FA_2019_154_1686.jpg

LM Start	0.76	Rating **	A/W	Issue No.	36
LM End	0.76	Issue Type +	Ma	Location *	WS
Category	Supplemental			GPS Latitude/Longitude	
				Start	End
Item	2017 Storm Damage			39.145240 °	39.145240 °
				-121.842650 °	-121.842650 °
DWR ID	RD 70-03				
Comment Code					
Inspector Comment					
Levee Evaluation Comments					
Description:					
Site ID No:154					
Site Designation:RD 70-03					
Repair Type: Erosion					
Rating:Area of Concern					
Field Date:7/17/2017					
Notes:

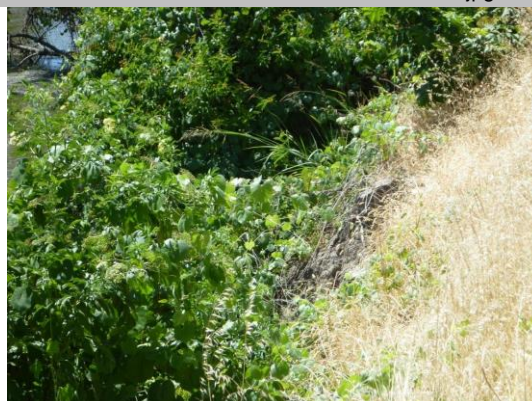
Photo 3 of 3 : LEVAL_FA_2019_154_1688.jpg

LM Start	0.76	Rating **	A/W	Issue No.	36 (cont)	
LM End	0.76	Issue Type +	Ma	Location *	WS	
Category	Supplemental			GPS Latitude/Longitude		
				Start	End	
Item	2017 Storm Damage			39.145240 °	39.145240 °	
				-121.842650 °	-121.842650 °	
DWR ID	RD 70-03					
Comment Code						
Inspector Comment						
Levee Evaluation Comments						
Description:						
Site ID No:154						
Site Designation:RD 70-03						
Repair Type: Erosion						
Rating:Area of Concern						
Field Date:7/17/2017						
Notes:

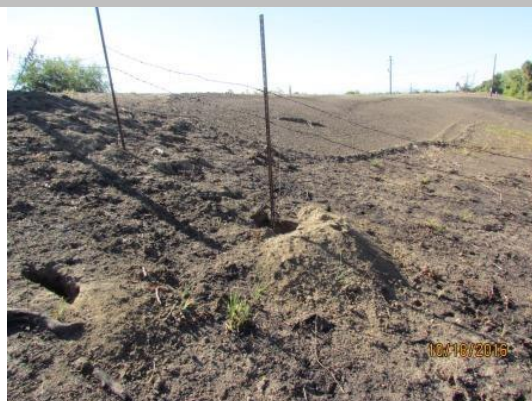
Photo 1 of 1 : FA_2019_RD0070_29_32_20190822_00006.jpg

LM Start	1.77	Rating **	M	Issue No.	32
LM End	1.77	Issue Type +	Ma	Location *	WS
Category	Earthen Levee			GPS Latitude/Longitude	
				Start	End
Item	Animal Control			39.151282°	39.151282°
				-121.855818°	-121.855818°
DWR ID	DWR_RD0070_01_f_2016_32				
Comment Code					
A3 : No rodents visible, but rodent burrows visible; need to backfill and compact or grout burrows.					
Inspector Comment

View of the rodent holes along the waterside slope.

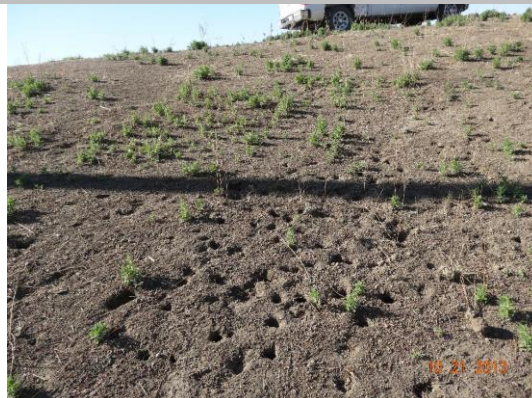
Photo 2 of 3 : UCIP_FA_2019_23508_40819.jpg

Comment Code						
Inspector Comment						
DS_ID:21336 FS_ID:23508 EP_NO: N/A Repair Type: Non-Urgent Crossing Status: Found UCIP Comments: Need to find owner to determine if crossing is still in use. If crossing is no longer in use owner will need to coordinate with DWR inspector and CVFPB to remove according to Title 23 requirements. Evidence of high burrow activity on waterward side recommend addressing issue. This crossing is referenced as USACE_CESPK_MRD1_2012_p_0230 in the USACE's PI report for no USACE recommendation letter available -- correction pipe is 12-inch not 16-inch. FIELD_STRUCT_DESC: 12-inch irrigation discharge pipe of an unknown material through the levee, 4 feet below the crown. Siphon breaker on the landside (LS) slope. 7-foot by 9-foot concrete distribution box at the LS toe. Service pole on the waterside (WS) slope. Pump on a concrete sump on the WS slope. Overhead power line crosses the levee. (Plans for the installation of a 12-inch steel irrigation pipe through the levee authorized under Permit No. 613, 1934 - Waldo M. Nall. Plans to retain a 12-inch pipe through the levee, 4 feet below the crown, pump, and siphon breaker authorized under Automatic Board Order (ABO) issued as Permit No. 9948, 1974 - Edward E. and Doris M. Nall). [Additional Reference(s): DWR Levee Log, 2007]. FS Date: 10/21/2013

Dense burrow activity found on waterward slope.

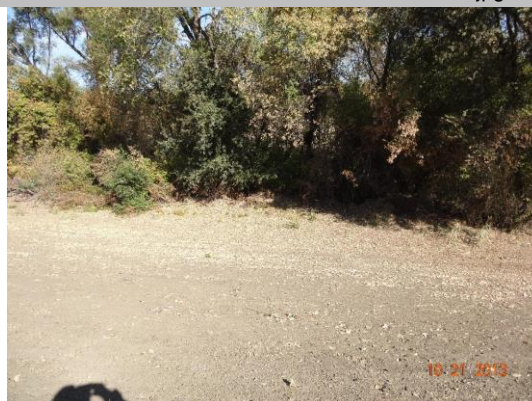
Photo 1 of 3 : UCIP_FA_2019_23530_40968.jpg

Comment Code					
Inspector Comment					
DS_ID:21322 FS_ID:23530 EP_NO: N/A Repair Type: Non-Urgent Crossing Status: Indicator Found UCIP Comments: Unable to determine if crossing exists need to coordinate with LMA to determine if more information is available about crossing. This crossing is referenced in the USACE Periodic Inspection as item USACE_CESPK_MRD1_2012_p_0208 for concrete ditch lined within 15 feet of LS toe, no water present, and no USACE recommendation letter available. FIELD_STRUCT_DESC: 12-inch steel irrigation discharge pipe through the levee, at an unknown depth. Cutoff wall around the pipe at the center of the levee. Slide gate on each end. Pump on the waterside (WS). Concrete distribution box on the landside (LS). [Additional Reference(s): USACE Sacramento O&M Manual 134, June 1953, (Station 142+70)]. FS Date: 10/21/2013

View of waterward side.

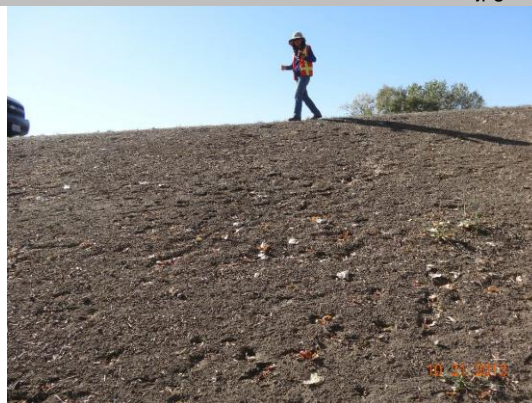
Photo 2 of 3 : UCIP_FA_2019_23530_40972.jpg

View of waterward slope.

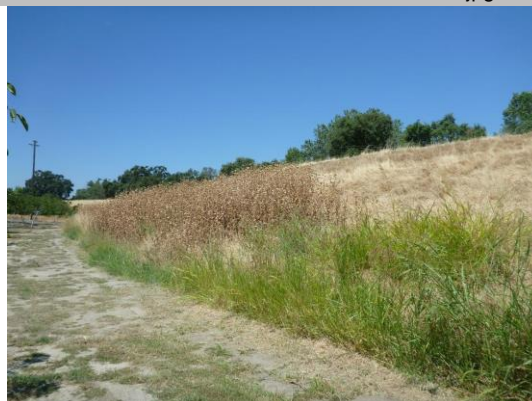
Photo 1 of 3 : LEVAL_FA_2019_153_1702.jpg

LM Start	3.18	Rating **	A/W	Issue No.	37
LM End	3.18	Issue Type +	Ob	Location *	
Category	Supplemental			GPS Latitude/Longitude	
				Start	End
Item	2017 Storm Damage			39.157480°	39.157480°
				-121.879250°	-121.879250°
DWR ID	RD 70-02				
Comment Code					
Inspector Comment					
Levee Evaluation Comments					
Description:					
Site ID No:153					
Site Designation:RD 70-02					
Repair Type: Seepage (B)					
Rating:Serious					
Field Date:7/17/2017					
Notes:

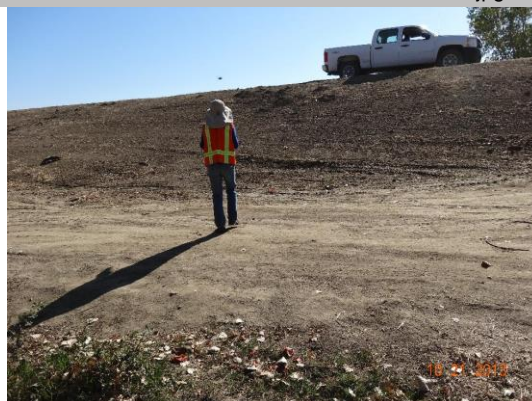
Photo 1 of 3 : UCIP_FA_2019_23506_40806.jpg

Comment Code						
Inspector Comment						
DS_ID:21361 FS_ID:23506 EP_NO: 9944 Repair Type: Non-Urgent Crossing Status: Found UCIP Comments: Burrow activity present on levee slopes. Multiple pipes found on landward side--are these pipes part of original crossing? This crossing is referenced in the USACE Periodic Inspection as item USACE_CESPK_MRD1_2012_p_0291--no USACE recommendation letter available. FIELD_STRUCT_DESC: 18-inch steel irrigation discharge pipe through the levee, 21.5 feet below the crown. Gate valve on the waterside (WS) end. Pipe discharges into a concrete box on the landside (LS). Rock revetment on the WS slope. (Retention of an 18-inch steel pipe through the levee, 21.5 feet below the crown, gate valve, and concrete box authorized under Automatic Board Order (ABO) issued as Permit No. 9944, 1974 - William J. and Marion D. Hankins). [Additional Reference(s): DWR Levee Log, 2007]. FS Date: 10/21/2013

View of waterward side slope and berm.

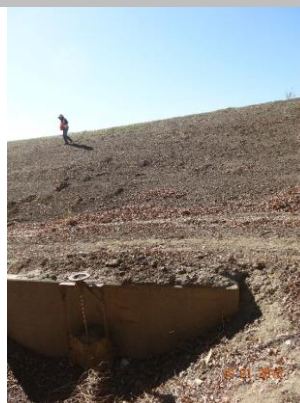
Photo 1 of 3 : UCIP_FA_2019_23510_40837.jpg

Comment Code					
Inspector Comment					
DS_ID:21362 FS_ID:23510 EP_NO: 9944 Repair Type: Non-Urgent Crossing Status: Found UCIP Comments: No pump connection. Need to coordinate with owner to determine status of crossing. If crossing is no longer in use owner will need to contact the CVFPB to comply with Title 23. This crossing is referenced in the USACE Periodic Inspection as item USACE_CESPK_MRD1_2012_p_0183 no USACE recommendation letter available. FIELD_STRUCT_DESC: 18-inch irrigation discharge pipe of an unknown material through the levee, 19.5 feet below the crown. Slide gate on the waterside (WS) end. Pump on the WS. Concrete distribution box on the landside (LS) slope. (Retention of an 18-inch pipe through the levee, 19.5 feet below the crown, and appurtenances authorized under Automatic Board Order (ABO) issued as Permit No. 9944, 1974 - William J. and Marion D. Hankins). [Additional Reference(s): DWR Levee Log, 2007. USACE Sacramento O&M Manual 134, June 1953, (Station 180+50)]. FS Date: 10/21/2013

Concrete head wall and screw gate at waterward toe.

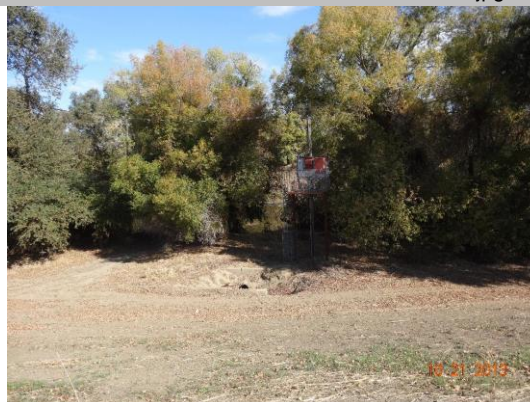
Photo 2 of 3 : UCIP_FA_2019_23510_40838.jpg

View of waterward side.

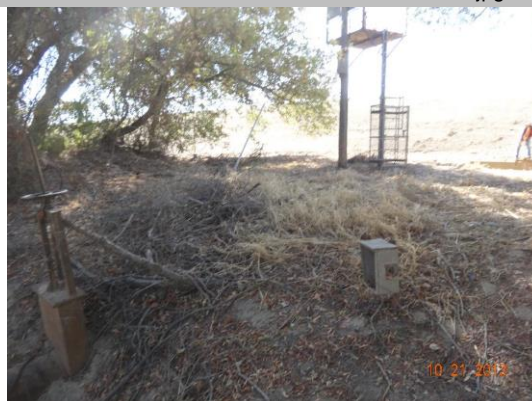
Photo 3 of 3 : UCIP_FA_2019_23510_40836.jpg

Comment Code						
Inspector Comment						
DS_ID:21362 FS_ID:23510 EP_NO: 9944 Repair Type: Non-Urgent Crossing Status: Found UCIP Comments: No pump connection. Need to coordinate with owner to determine status of crossing. If crossing is no longer in use owner will need to contact the CVFPB to comply with Title 23. This crossing is referenced in the USACE Periodic Inspection as item USACE_CESPK_MRD1_2012_p_0183 no USACE recommendation letter available. FIELD_STRUCT_DESC: 18-inch irrigation discharge pipe of an unknown material through the levee, 19.5 feet below the crown. Slide gate on the waterside (WS) end. Pump on the WS. Concrete distribution box on the landside (LS) slope. (Retention of an 18-inch pipe through the levee, 19.5 feet below the crown, and appurtenances authorized under Automatic Board Order (ABO) issued as Permit No. 9944, 1974 - William J. and Marion D. Hankins). [Additional Reference(s): DWR Levee Log, 2007. USACE Sacramento O&M Manual 134, June 1953, (Station 180+50)]. FS Date: 10/21/2013

View of appurtenances located on waterward side.

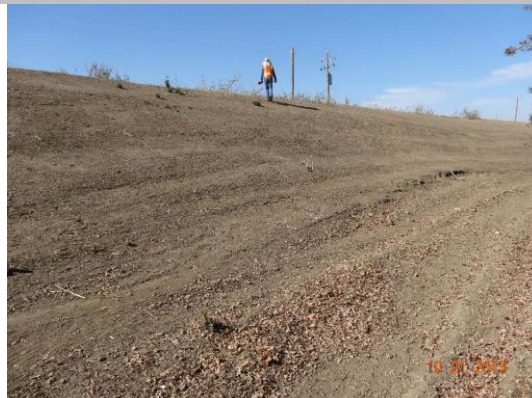
Photo 1 of 3 : UCIP_FA_2019_23515_40867.jpg

View of waterward slope.

Item	DRAFT DWR UCIP Field Study		39.166859 °	39.166859 °								
			-121.898846 °	-121.898846 °								
DWR ID	21364											
Comment Code												
Inspector Comment												
DS_ID:21364 FS_ID:23515 EP_NO: 9954 Repair Type: Non-Urgent Crossing Status: Found UCIP Comments: Power pole down on waterward side. Need to coordinate with owner to determine status of crossing. If crossing is no longer in use owner will need to contact the CVFPB to comply with Title 23. This crossing is referenced in the USACE Periodic Inspection as item USACE_CESPK_MRD1_2012_p_0147. FIELD_STRUCT_DESC: 18-inch (not 24-inch as referenced in the permit) steel irrigation discharge pipe through the levee, 18 feet below the crown. Pipe crosses the levee at a 45 degree angle. Slide gate in a 5-foot by 5-foot concrete box at the waterside (WS) toe. Pump in a pump house on the WS, not found. Discharge box at the landside (LS) toe. Power pole at the WS toe. (Retention of a 24-inch steel pipe through the levee, 18 feet below the crown, pump, slide gate, and discharge box authorized under Automatic Board Order (ABO) issued as Permit No. 9954, 1974 - Parker A. Reische). [Additional Reference(s): DWR Levee Log, 2007]. FS Date: 10/21/2013

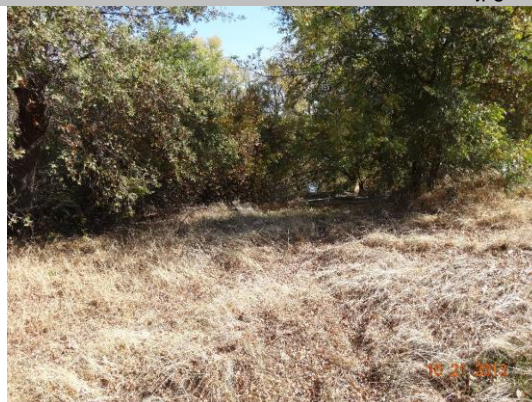
Photo 2 of 3 : UCIP_FA_2019_23515_40868.jpg

View of waterward side.

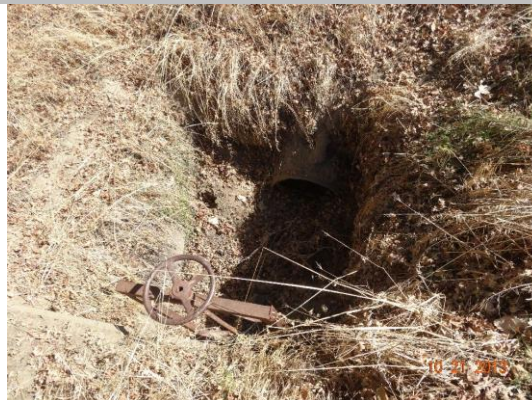
Photo 3 of 3 : UCIP_FA_2019_23515_40869.jpg

View of concrete box located on waterward side, photo 2 of 2.

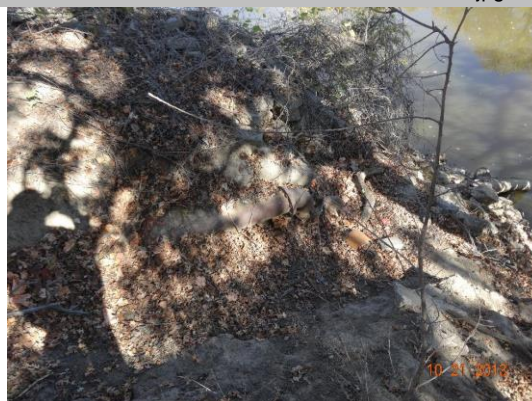
Photo 1 of 3 : UCIP_FA_2019_23516_40873.jpg

View of pipe located on waterward side.

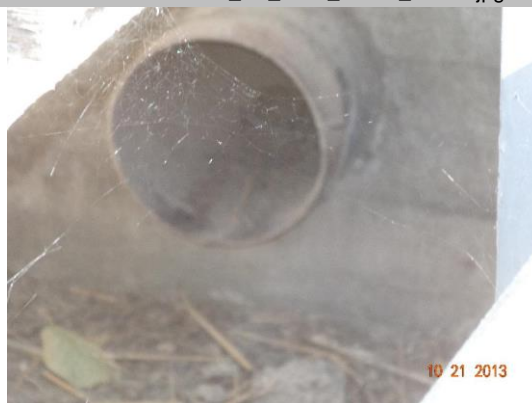
Photo 2 of 3 : UCIP_FA_2019_23516_40872.jpg

View of pipe on landward side inside concrete distribution box.

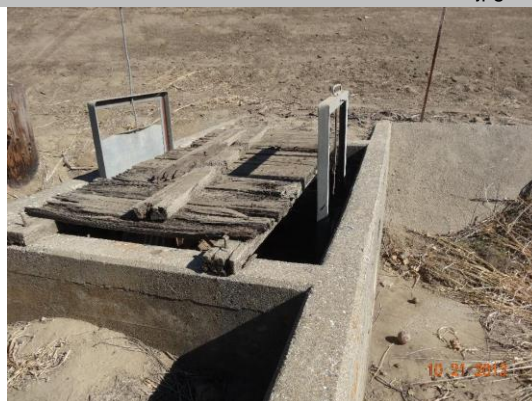
Photo 3 of 3 : UCIP_FA_2019_23516_40874.jpg

Comment Code						
Inspector Comment						
DS_ID:21339 FS_ID:23516 EP_NO: 9951 Repair Type: Non-Urgent Crossing Status: Found UCIP Comments: Need to coordinate with owner to determine status of crossing. If crossing is no longer in use owner will need to contact the CVFPB to comply with Title 23. This crossing is referenced in the USACE Periodic Inspection as item USACE_CESPK_MRD1_2012_p_0144. FIELD_STRUCT_DESC: 10-inch steel irrigation pipe through the levee, 16.3 feet below the crown. Pipe crosses the levee at a 45 degree angle. Siphon breaker in a corrugated metal pipe (CMP) riser on the landside (LS) slope. Gate valve on the waterside (WS) end. Pipe discharges into a concrete discharge box. (Plans to retain a 10-inch steel pipe through the levee, 16.3 feet below the crown, a gate valve, a siphon breaker in a CMP riser, and a concrete discharge box authorized under Automatic Board Order (ABO) issued as Permit No. 9951, 1974 - Frank and Mischa Pirtle). [Additional Reference(s): DWR Levee Log, 2007]. FS Date: 10/21/2013

Concrete distribution box located at landward toe.

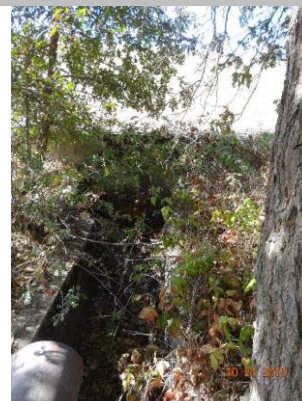
Photo 2 of 3 : UCIP_FA_2019_23517_40877.jpg

Comment Code						
Inspector Comment						
DS_ID:21340 FS_ID:23517 EP_NO: 9954 Repair Type: Non-Urgent Crossing Status: Found UCIP Comments: Burrow activity present on waterward slope. Need to coordinate with owner to determine status of crossing. If crossing is no longer in use owner will need to contact the CVFPB to comply with Title 23. This crossing is referenced in the USACE Periodic Inspection as item USACE_CESPK_MRD1_2012_p_0134. FIELD_STRUCT_DESC: 24-inch corrugated metal irrigation discharge pipe through the levee, 19 feet below the crown. Slide gate on the waterside (WS). Concrete distribution box at the landside (LS) toe. (Retention of a 24-inch corrugated metal pipe (CMP) through the levee, 19 feet below the crown, a slide gate, and a concrete distribution box authorized under Automatic Board Order (ABO) issued as Permit No. 9954, 1974 - Parker A. Reische). [Additional Reference(s): DWR Levee Log, 2007]. FS Date: 10/21/2013

View of pipe located on waterward side.

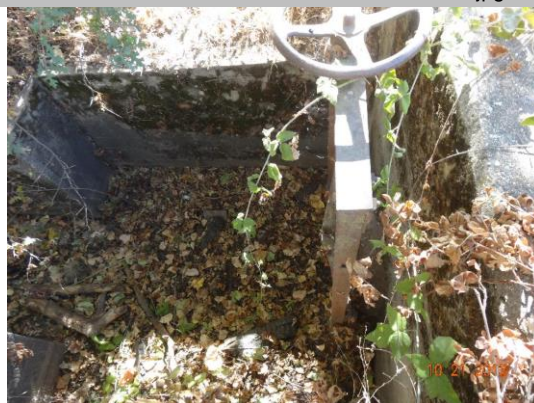
Photo 3 of 3 : UCIP_FA_2019_23517_40882.jpg

Comment Code						
Inspector Comment						
DS_ID:21340 FS_ID:23517 EP_NO: 9954 Repair Type: Non-Urgent Crossing Status: Found UCIP Comments: Burrow activity present on waterward slope. Need to coordinate with owner to determine status of crossing. If crossing is no longer in use owner will need to contact the CVFPB to comply with Title 23. This crossing is referenced in the USACE Periodic Inspection as item USACE_CESPK_MRD1_2012_p_0134. FIELD_STRUCT_DESC: 24-inch corrugated metal irrigation discharge pipe through the levee, 19 feet below the crown. Slide gate on the waterside (WS). Concrete distribution box at the landside (LS) toe. (Retention of a 24-inch corrugated metal pipe (CMP) through the levee, 19 feet below the crown, a slide gate, and a concrete distribution box authorized under Automatic Board Order (ABO) issued as Permit No. 9954, 1974 - Parker A. Reische). [Additional Reference(s): DWR Levee Log, 2007]. FS Date: 10/21/2013

View of slide gate on waterward side.

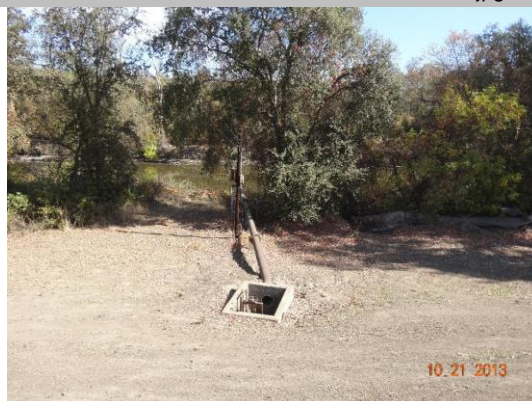
Photo 1 of 3 : UCIP_FA_2019_23518_40886.jpg

Comment Code					
Inspector Comment					
DS_ID:21338 FS_ID:23518 EP_NO: 9940 Repair Type: Non-Urgent Crossing Status: Found UCIP Comments: No connection present--need to contact owner to determine if owner plans to use. If crossing is no longer in use owner will need to coordinate with DWR inspector and CVFPB to remove according to Title 23 requirements. Unable to determine if crossing is in use. This crossing is referenced in the USACE Periodic Inspection as item USACE_CESPK_MRD1_2012_p_0125. FIELD_STRUCT_DESC: 18-inch steel irrigation discharge pipe through the levee, 19 feet below the crown. Cutoff wall around the pipe at the center of the levee. Slide gate in a concrete distribution box on the landside (LS). Pump on the waterside (WS). Pipe discharges into a concrete box on the LS. (Retention of an 18-inch steel pipe through the levee, 19 feet below the crown, a pump, a slide gate in a concrete distribution box, and a concrete box authorized under Automatic Board Order (ABO) issued as Permit No. 9940, 1974 - Pearl Clark, et al.). [Additional Reference(s): DWR Levee Log, 2007. USACE Sacramento O&M Manual 134, June 1953, (Station 251+30)]. FS Date: 10/21/2013

View of waterward side--pipe and concrete distribution box.

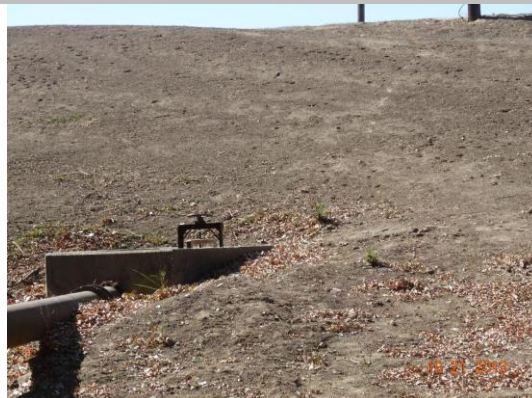
Photo 2 of 3 : UCIP_FA_2019_23518_40887.jpg

View of waterward slope.

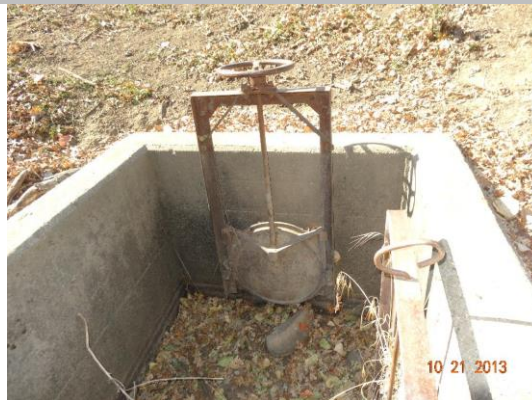
Photo 3 of 3 : UCIP_FA_2019_23518_40890.jpg

Comment Code						
Inspector Comment						
DS_ID:21338 FS_ID:23518 EP_NO: 9940 Repair Type: Non-Urgent Crossing Status: Found UCIP Comments: No connection present--need to contact owner to determine if owner plans to use. If crossing is no longer in use owner will need to coordinate with DWR inspector and CVFPB to remove according to Title 23 requirements. Unable to determine if crossing is in use. This crossing is referenced in the USACE Periodic Inspection as item USACE_CESPK_MRD1_2012_p_0125. FIELD_STRUCT_DESC: 18-inch steel irrigation discharge pipe through the levee, 19 feet below the crown. Cutoff wall around the pipe at the center of the levee. Slide gate in a concrete distribution box on the landside (LS). Pump on the waterside (WS). Pipe discharges into a concrete box on the LS. (Retention of an 18-inch steel pipe through the levee, 19 feet below the crown, a pump, a slide gate in a concrete distribution box, and a concrete box authorized under Automatic Board Order (ABO) issued as Permit No. 9940, 1974 - Pearl Clark, et al.). [Additional Reference(s): DWR Levee Log, 2007. USACE Sacramento O&M Manual 134, June 1953, (Station 251+30)]. FS Date: 10/21/2013

Screw gate located inside concrete distribution box located on waterward side.

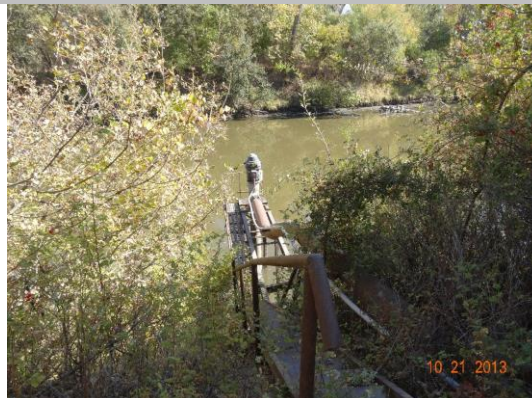
Photo 1 of 3 : UCIP_FA_2019_23519_40896.jpg

Comment Code						
Inspector Comment						
DS_ID:21357 FS_ID:23519 EP_NO: 9957 Repair Type: Non-Urgent Crossing Status: Found UCIP Comments: Burrow activity on slopes -- recommend addressing issue. This crossing is referenced in the USACE Periodic Inspection as item USACE_CESPK_MRD1_2012_p_0110. FIELD_STRUCT_DESC: 12-inch steel irrigation discharge pipe through the levee, 5.5 feet below the crown. Pump on the waterside (WS) slope. Siphon breaker in a corrugated metal pipe (CMP) riser on the landside (LS) slope. Pipe discharges into a concrete box at the LS toe. Service pole at the LS toe. (Plans to retain a 12-inch steel pipe through the levee, 5.5 feet below the crown, a siphon breaker in a CMP riser, a pump, and a concrete box authorized under Automatic Board Order (ABO) issued as Permit No. 9957, 1974 - James E. and Mattie Smith). [Additional Reference(s): DWR Levee Log, 2007]. FS Date: 10/21/2013

View of waterward side--pump, pipe, and walkway.

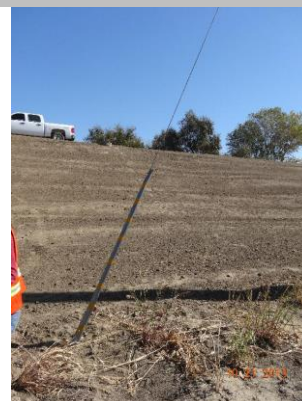
Photo 3 of 3 : UCIP_FA_2019_23519_40897.jpg

Comment Code						
Inspector Comment						
DS_ID:21357 FS_ID:23519 EP_NO: 9957 Repair Type: Non-Urgent Crossing Status: Found UCIP Comments: Burrow activity on slopes -- recommend addressing issue. This crossing is referenced in the USACE Periodic Inspection as item USACE_CESPK_MRD1_2012_p_0110. FIELD_STRUCT_DESC: 12-inch steel irrigation discharge pipe through the levee, 5.5 feet below the crown. Pump on the waterside (WS) slope. Siphon breaker in a corrugated metal pipe (CMP) riser on the landside (LS) slope. Pipe discharges into a concrete box at the LS toe. Service pole at the LS toe. (Plans to retain a 12-inch steel pipe through the levee, 5.5 feet below the crown, a siphon breaker in a CMP riser, a pump, and a concrete box authorized under Automatic Board Order (ABO) issued as Permit No. 9957, 1974 - James E. and Mattie Smith). [Additional Reference(s): DWR Levee Log, 2007]. FS Date: 10/21/2013

View of landward slope.

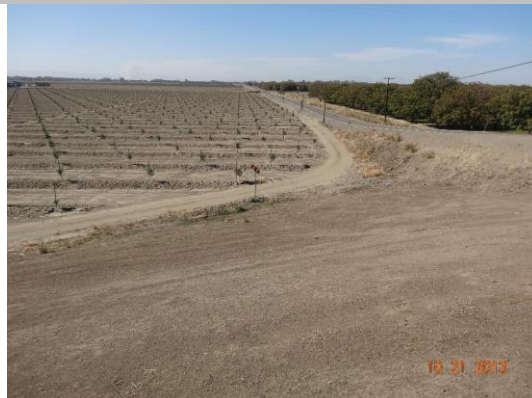
Photo 1 of 3 : UCIP_FA_2019_23479_40724.jpg

Comment Code					
Inspector Comment					
DS_ID:21360 FS_ID:23479 EP_NO: 4867 Repair Type: Non-Urgent Crossing Status: Found UCIP Comments: Utility marker contact information includes Contact prior to Excavation call 1-800-227-2600 or Emergency Contact 1-800-811-4111. Need to contact owner to determine status of crossing. Need date of last inspection and confirmation that crossing is still in operable condition. FIELD_STRUCT_DESC: 6.5-inch coated steel natural gas pipeline through the levee, 4 feet below the crown. Concrete cutoff wall around the pipe at the center of the levee. Rock revetment on the waterside (WS) slope. (Plans for installing a gas line through the levee authorized under Permit No. 4867, 1965 - Pacific Gas and Electric Company [PG&E]). [Additional Reference(s): DWR Levee Log, 2007]. FS Date: 10/21/2013

View of landward side.

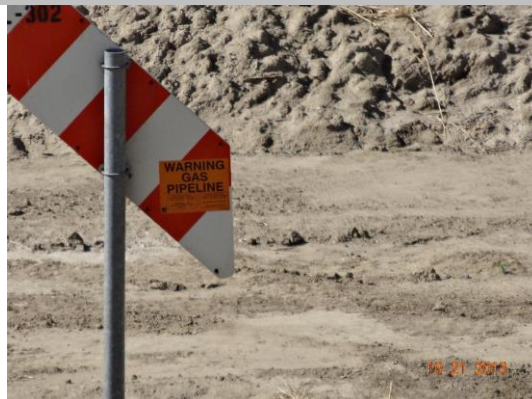
Photo 2 of 3 : UCIP_FA_2019_23479_40723.jpg

Pipeline marker on landward side.

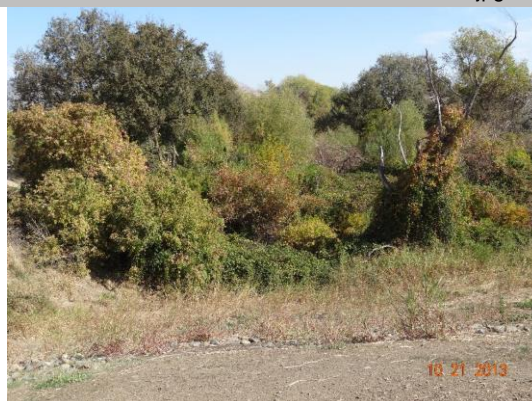
Photo 3 of 3 : UCIP_FA_2019_23479_40722.jpg

Comment Code						
Inspector Comment						
DS_ID:21360 FS_ID:23479 EP_NO: 4867 Repair Type: Non-Urgent Crossing Status: Found UCIP Comments: Utility marker contact information includes Contact prior to Excavation call 1-800-227-2600 or Emergency Contact 1-800-811-4111. Need to contact owner to determine status of crossing. Need date of last inspection and confirmation that crossing is still in operable condition. FIELD_STRUCT_DESC: 6.5-inch coated steel natural gas pipeline through the levee, 4 feet below the crown. Concrete cutoff wall around the pipe at the center of the levee. Rock revetment on the waterside (WS) slope. (Plans for installing a gas line through the levee authorized under Permit No. 4867, 1965 - Pacific Gas and Electric Company [PG&E]). [Additional Reference(s): DWR Levee Log, 2007]. FS Date: 10/21/2013

View of waterward side.

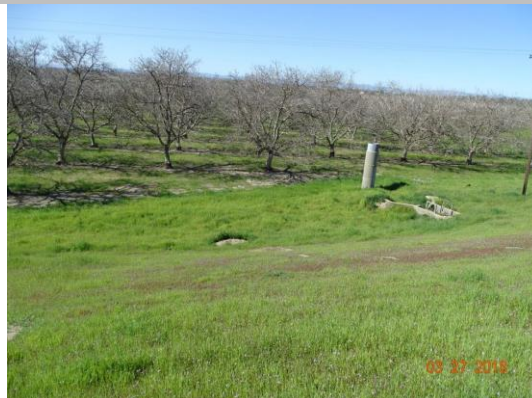
Photo 1 of 1 : FA_2019_RD0070_29_40_20190822_00016.jpg

LM Start	6.57	Rating **	U	Issue No.	40
LM End	6.57	Issue Type +	Ma	Location *	LS
Category	Earthen Levee			GPS Latitude/Longitude	
				Start	End
Item	Animal Control			39.192283°	39.192283°
				-121.914388°	-121.914388°
DWR ID	DWR_RD0070_01_f_2018_40				
Comment Code					
A3 : No rodents visible, but rodent burrows visible; need to backfill and compact or grout burrows.					
Inspector Comment					
Several large rodent holes were observed in this area.

View of rodent holes along the landside slope.

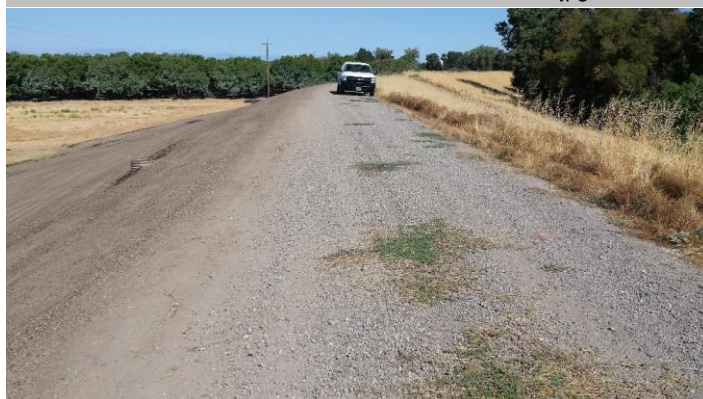
Photo 1 of 3 : UCIP_FA_2019_46422_74619.jpg

Comment Code					
Inspector Comment					
DS_ID:21341 FS_ID:46422 EP_NO: 9960 Repair Type: Non-Urgent Crossing Status: Found UCIP Comments: 07/28/2015 Pipe appears still appears abandoned. Priority was downgraded from Urgent to Non-Urgent due to the inactivity. Need to contact owner to confirm status and future use. If crossing is no longer in use owner will need to coordinate with DWR inspector and CVFPB to remove according to Title 23 requirements.10/21/2013 Hole present on pipe on waterward side. This crossing was determined urgent due to hole on pipe-no signs leaks present on waterward or landward slopes. Unable to find if crossing is being used. Need to contact owner to determine crossing is still in use. If crossing is no longer in use owner will need to coordinate with DWR inspector and CVFPB to remove according to Title 23 requirements. Unable to determine if crossing is in use. This crossing is referenced in the USACE Periodic Inspection as item USACE_CESPK_MRD1_2012_p_0069. FIELD_STRUCT_DESC: 12-inch steel pipe of an unknown purpose through the levee, 6.2 feet below the crown. Siphon breaker in a corrugated metal pipe (CMP) riser on the landside (LS) slope. Service pole on the LS shoulder. Concrete distribution box at the LS toe. (Retention of a 12-inch steel pipe through the levee, 6.2 feet below the crown, a siphon breaker in a CMP riser, a service pole, and a concrete distribution box authorized under Automatic Board Order (ABO) issued as Permit No. 9960, 1974 - Richard L. and Mildred E. Tarke). [Additional Reference(s): DWR Levee Log, 2007. USACE Sacramento O&M Manual 134, June 1953, (Station 332+72)]. FS Date: 7/28/2015 3:30:00 PM

Overview of levee crown at crossing. No change from last inspection.

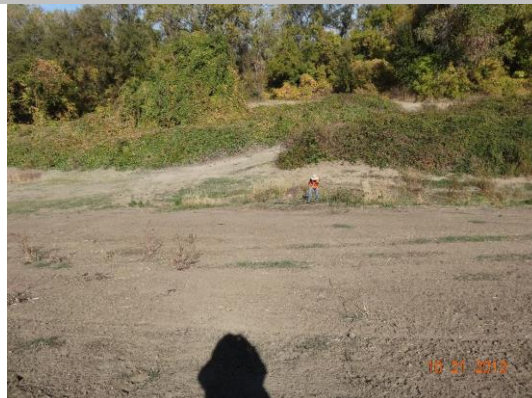
Photo 2 of 3 : UCIP_FA_2019_46422_40914.jpg

Comment Code						
Inspector Comment						
DS_ID:21341 FS_ID:46422 EP_NO: 9960 Repair Type: Non-Urgent Crossing Status: Found UCIP Comments: 07/28/2015 Pipe appears still appears abandoned. Priority was downgraded from Urgent to Non-Urgent due to the inactivity. Need to contact owner to confirm status and future use. If crossing is no longer in use owner will need to coordinate with DWR inspector and CVFPB to remove according to Title 23 requirements.10/21/2013 Hole present on pipe on waterward side. This crossing was determined urgent due to hole on pipe-no signs leaks present on waterward or landward slopes. Unable to find if crossing is being used. Need to contact owner to determine crossing is still in use. If crossing is no longer in use owner will need to coordinate with DWR inspector and CVFPB to remove according to Title 23 requirements. Unable to determine if crossing is in use. This crossing is referenced in the USACE Periodic Inspection as item USACE_CESPK_MRD1_2012_p_0069. FIELD_STRUCT_DESC: 12-inch steel pipe of an unknown purpose through the levee, 6.2 feet below the crown. Siphon breaker in a corrugated metal pipe (CMP) riser on the landside (LS) slope. Service pole on the LS shoulder. Concrete distribution box at the LS toe. (Retention of a 12-inch steel pipe through the levee, 6.2 feet below the crown, a siphon breaker in a CMP riser, a service pole, and a concrete distribution box authorized under Automatic Board Order (ABO) issued as Permit No. 9960, 1974 - Richard L. and Mildred E. Tarke). [Additional Reference(s): DWR Levee Log, 2007. USACE Sacramento O&M Manual 134, June 1953, (Station 332+72)]. FS Date: 7/28/2015 3:30:00 PM

View of waterward side.

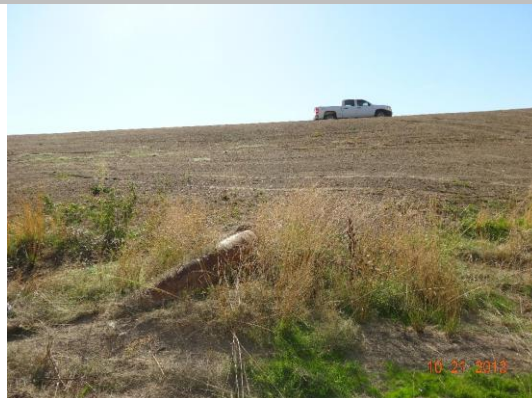
Photo 3 of 3 : UCIP_FA_2019_46422_40913.jpg

Comment Code						
Inspector Comment						
DS_ID:21341 FS_ID:46422 EP_NO: 9960 Repair Type: Non-Urgent Crossing Status: Found UCIP Comments: 07/28/2015 Pipe appears still appears abandoned. Priority was downgraded from Urgent to Non-Urgent due to the inactivity. Need to contact owner to confirm status and future use. If crossing is no longer in use owner will need to coordinate with DWR inspector and CVFPB to remove according to Title 23 requirements.10/21/2013 Hole present on pipe on waterward side. This crossing was determined urgent due to hole on pipe-no signs leaks present on waterward or landward slopes. Unable to find if crossing is being used. Need to contact owner to determine crossing is still in use. If crossing is no longer in use owner will need to coordinate with DWR inspector and CVFPB to remove according to Title 23 requirements. Unable to determine if crossing is in use. This crossing is referenced in the USACE Periodic Inspection as item USACE_CESPK_MRD1_2012_p_0069. FIELD_STRUCT_DESC: 12-inch steel pipe of an unknown purpose through the levee, 6.2 feet below the crown. Siphon breaker in a corrugated metal pipe (CMP) riser on the landside (LS) slope. Service pole on the LS shoulder. Concrete distribution box at the LS toe. (Retention of a 12-inch steel pipe through the levee, 6.2 feet below the crown, a siphon breaker in a CMP riser, a service pole, and a concrete distribution box authorized under Automatic Board Order (ABO) issued as Permit No. 9960, 1974 - Richard L. and Mildred E. Tarke). [Additional Reference(s): DWR Levee Log, 2007. USACE Sacramento O&M Manual 134, June 1953, (Station 332+72)]. FS Date: 7/28/2015 3:30:00 PM

View of waterward slope and pipe at levee toe.

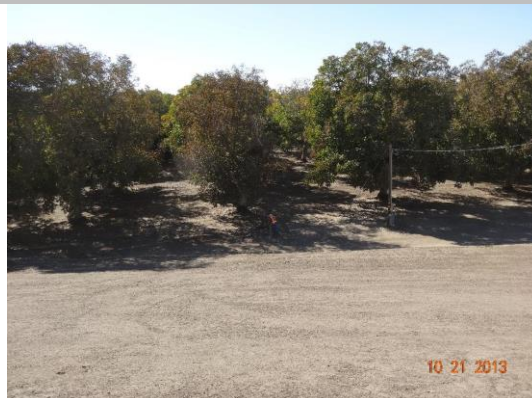
Photo 1 of 2 : UCIP_FA_2019_49188_40922.jpg

Comment Code						
Inspector Comment						
DS_ID:21342 FS_ID:49188 EP_NO: N/A Repair Type: Non-Urgent Crossing Status: Indicator Found UCIP Comments: 06/21/2016 This crossing has been modified DWR levee log indicates 12-inch pipe not a 8-inch pipe, unable to determine if pipe goes through levee. This crossing appears to be an irrigation line. Need to find owner to clarify pipe use, determine whether pipe goes through levee, and determine the fate of the original 12-inch pipe through the levee.10/21/2013 Unable to determine if this is an irrigation pipe or groundwater pipe. This crossing is referenced in the USACE Periodic Inspection as item USACE_CESPK_MRD1_2012_p_0062--no permit available. FIELD_STRUCT_DESC: 8-inch (not 12-inch as found in desk study) pipe of an unknown material or purpose through the levee, at an unknown depth. Pump and service pole at the landside (LS) toe. [Additional Reference(s): DWR Levee Log, 2007]. FS Date: 10/21/2013

View of landward side.

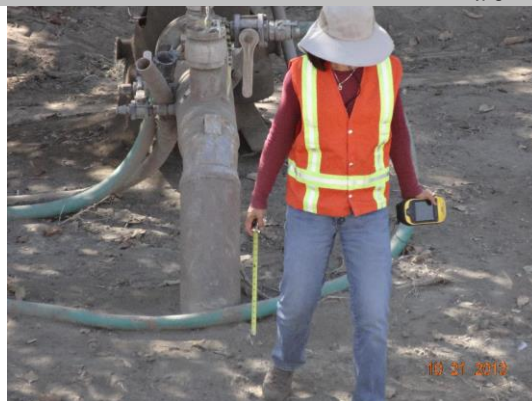
Photo 2 of 2 : UCIP_FA_2019_49188_40921.jpg

Pump system and pipe on landward side.

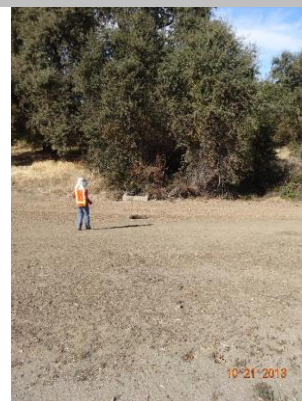
Photo 1 of 3 : UCIP_FA_2019_23529_40964.jpg

Comment Code						
Inspector Comment						
DS_ID:21345 FS_ID:23529 EP_NO: 9942 Repair Type: Non-Urgent Crossing Status: Found UCIP Comments: Dense vegetation limits the inspector's visibility to identify signs of pipe failure (leaks) along the slope. Recommend removing vegetation along pipe alignment to conduct proper inspection of structure and appurtenances. This crossing is referenced in the USACE Periodic Inspection as item USACE_CESPK_MRD1_2012_p_0005. FIELD_STRUCT_DESC: 24-inch corrugated metal irrigation discharge pipe through the levee, 16.5 feet below the crown. Incline pump on the waterside (WS). Slide gate in a corrugated metal pipe (CMP) riser on the WS slope. Pipe discharges into a concrete box at the landside (LS) toe. Service pole on the LS. (Retention of a 24-inch CMP through the levee, 16.5 feet below the crown, a slant pump, a slide gate in a CMP riser, a box, and a service pole authorized under Automatic Board Order (ABO) issued as Permit No. 9942, 1974 - R. W. and H. Evelyn Draper). [Additional Reference(s): DWR Levee Log, 2007. USACE Sacramento O&M Manual 134, June 1953, (Station 330+00)]. FS Date: 10/21/2013

View of waterward slope.

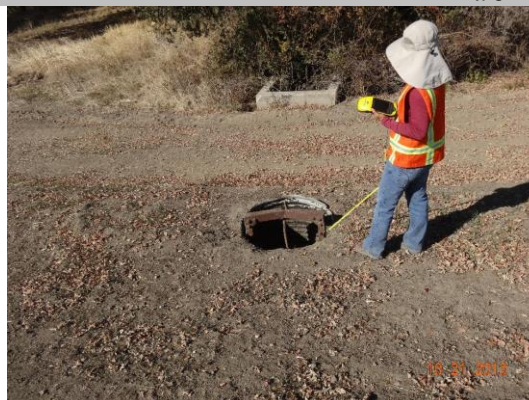
Photo 2 of 3 : UCIP_FA_2019_23529_40963.jpg

CMP riser with screw gate inside. Gate is missing the handle to close gate.

Item	DRAFT DWR UCIP Field Study		39.195148°	39.195148°								
			-121.933849°	-121.933849°								
DWR ID	21345											
Comment Code												
Inspector Comment												
DS_ID:21345 FS_ID:23529 EP_NO: 9942 Repair Type: Non-Urgent Crossing Status: Found UCIP Comments: Dense vegetation limits the inspector's visibility to identify signs of pipe failure (leaks) along the slope. Recommend removing vegetation along pipe alignment to conduct proper inspection of structure and appurtenances. This crossing is referenced in the USACE Periodic Inspection as item USACE_CESPK_MRD1_2012_p_0005. FIELD_STRUCT_DESC: 24-inch corrugated metal irrigation discharge pipe through the levee, 16.5 feet below the crown. Incline pump on the waterside (WS). Slide gate in a corrugated metal pipe (CMP) riser on the WS slope. Pipe discharges into a concrete box at the landside (LS) toe. Service pole on the LS. (Retention of a 24-inch CMP through the levee, 16.5 feet below the crown, a slant pump, a slide gate in a CMP riser, a box, and a service pole authorized under Automatic Board Order (ABO) issued as Permit No. 9942, 1974 - R. W. and H. Evelyn Draper). [Additional Reference(s): DWR Levee Log, 2007. USACE Sacramento O&M Manual 134, June 1953, (Station 330+00)]. FS Date: 10/21/2013

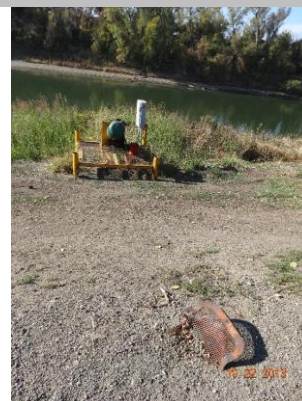
Photo 1 of 3 : UCIP_FA_2019_52618_42061.jpg

DS_ID:21382
FS_ID:52618
EP_NO: 12707
Repair Type: Urgent
Crossing Status: Found
UCIP Comments: 05/16/2018 2-foot round depression on waterward side found 4.5' from levee crown (Marty Rd). 14'x8'x3' excavation found on waterside slope to expose 14"-pipe. Evidence of internal erosion found at the bottom of excavation toward the pump. Cracks in asphalt pavement found on levee crown. (O.Yakimov - DWR UCIP)
11/03/2017 Crossing failed on WS and section of the levee was exposed to determine the extend of pipe damage by owner. Pipe is an up and over crossing. Crossing has been upgraded from Non-Urgent to Urgent due to pipe failure and exposed section of the levee visible on WS. (DWR UCIP - O. Magana)10/22/2013 Burrow activity noticed at this location. Crossing appurtenances have been modified. No 36-inch concrete distribution stand pipe present instead there is a concrete distribution box located at the landward toe. Also siphon breaker housing unit damage. Will need to contact owner. Need to obtain maintenance records and clarify modifications made at to crossing. Recommend having owner clear vegetation on waterward side. This crossing is referenced in the USACE Periodic Inspection as item USACE_CESPK_MRD2_2012_p_0018.

FIELD_STRUCT_DESC: 14-inch coated steel irrigation discharge pipe through the levee, 3 feet below the crown. Steel cutoff wall around the pipe at the center of the levee. Pump on a metal platform (not timber as noted in the desk study) on the waterside (WS). Siphon breaker on the apex of the pipe at the WS shoulder. 36-inch concrete standpipe at the landside (LS) toe, not found during October 2013 inspection. Service pole at the LS toe. Rock revetment on the WS slope. (Plans to install a 30-kilowatt [40-horsepower] pump on the riverbank with a 14-inch steel discharge pipe through the levee authorized under Permit No. 12707, 1979 - Roger C. Wilber, Butte Creek Farms). [Additional Reference(s): DWR Levee Log, 2007].
FS Date: 5/16/2018

View of waterward side--siphon breaker housing unit, pipe daylight, pump, and platform.

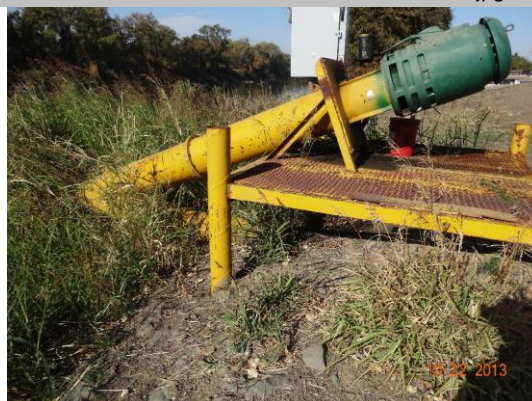
Photo 2 of 3 : UCIP_FA_2019_52618_42060.jpg

DS_ID:21382
FS_ID:52618
EP_NO: 12707
Repair Type: Urgent
Crossing Status: Found
UCIP Comments: 05/16/2018 2-foot round depression on waterward side found 4.5' from levee crown (Marty Rd). 14'x8'x3' excavation found on waterside slope to expose 14"-pipe. Evidence of internal erosion found at the bottom of excavation toward the pump. Cracks in asphalt pavement found on levee crown. (O.Yakimov - DWR UCIP)
11/03/2017 Crossing failed on WS and section of the levee was exposed to determine the extend of pipe damage by owner. Pipe is an up and over crossing. Crossing has been upgraded from Non-Urgent to Urgent due to pipe failure and exposed section of the levee visible on WS. (DWR UCIP - O. Magana)10/22/2013 Burrow activity noticed at this location. Crossing appurtenances have been modified. No 36-inch concrete distribution stand pipe present instead there is a concrete distribution box located at the landward toe. Also siphon breaker housing unit damage. Will need to contact owner. Need to obtain maintenance records and clarify modifications made at to crossing. Recommend having owner clear vegetation on waterward side. This crossing is referenced in the USACE Periodic Inspection as item USACE_CESPK_MRD2_2012_p_0018.

View of pump on waterward side.

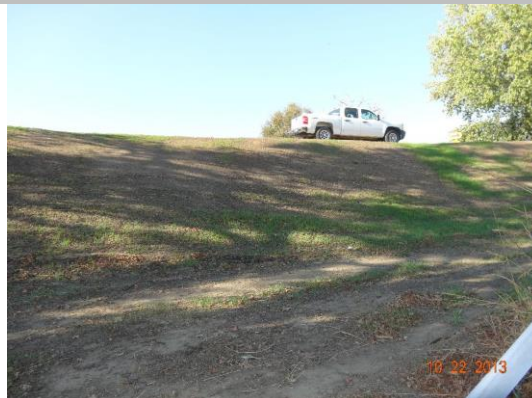
Photo 3 of 3 : UCIP_FA_2019_52618_42062.jpg

FIELD_STRUCT_DESC: 14-inch coated steel irrigation discharge pipe through the levee, 3 feet below the crown. Steel cutoff wall around the pipe at the center of the levee. Pump on a metal platform (not timber as noted in the desk study) on the waterside (WS). Siphon breaker on the apex of the pipe at the WS shoulder. 36-inch concrete standpipe at the landside (LS) toe, not found during October 2013 inspection. Service pole at the LS toe. Rock revetment on the WS slope. (Plans to install a 30-kilowatt [40-horsepower] pump on the riverbank with a 14-inch steel discharge pipe through the levee authorized under Permit No. 12707, 1979 - Roger C. Wilber, Butte Creek Farms). [Additional Reference(s): DWR Levee Log, 2007].
FS Date: 5/16/2018

View of levee slope on landward side.

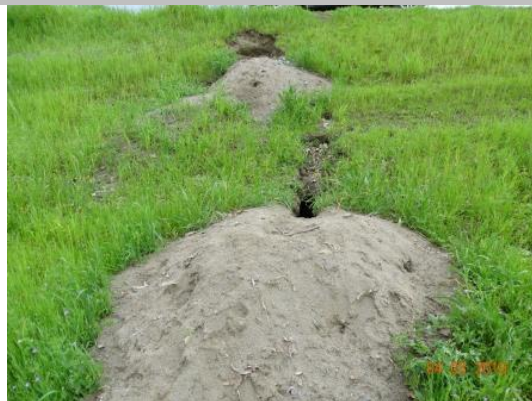
Photo 1 of 1 : FA_2019_RD0070_30_101_20190822_00030.jpg

LM Start	0.85	Rating **	U	Issue No.	101
LM End	0.85	Issue Type +	Ma	Location *	WS
Category	Earthen Levee			GPS Latitude/Longitude	
				Start	End
Item	Animal Control			39.185567 °	39.185567 °
				-121.941427 °	-121.941427 °
DWR ID	DWR_RD0070_02_s_2019_101				
Comment Code					
A3 : No rodents visible, but rodent burrows visible; need to backfill and compact or grout burrows.					
Inspector Comment

View of large rodent holes on the waterside slope. Spring 2019.
